The Chesters, Drem, East Lothian

Erosion Survey

Rampart Scotland Project 002:

Season 4

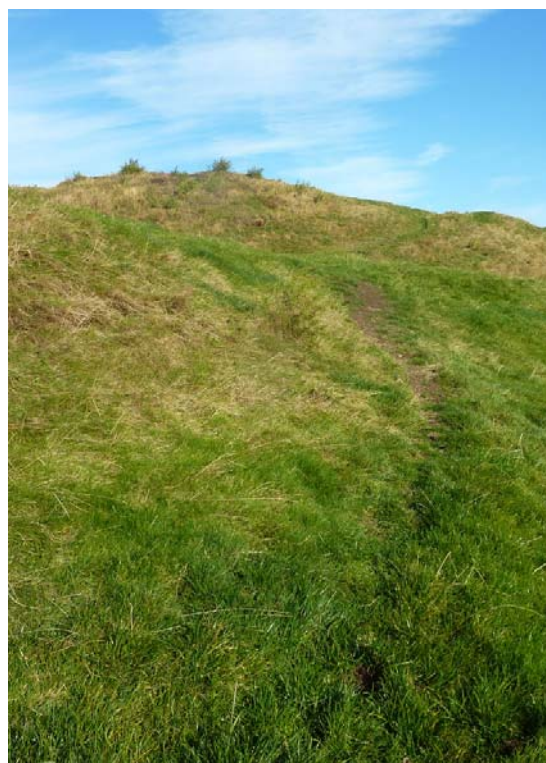
7.1.1 The damage from visitors continues to be localised and clearly follows established paths. Visitor access is focussed along Tracks 1 and 2, leading directly into the interior, and there is no evidence for *ad hoc* alternative routes. Of course while this activity minimises the overall spread of erosion it concentrates it in particular locations. The new entry has had no effect on visitor activity, as they seem to continue on the old routes after entering the site via the new pathway.

PLATE 1: VISITOR DAMAGE 2 THROUGH UPPER RAMPART

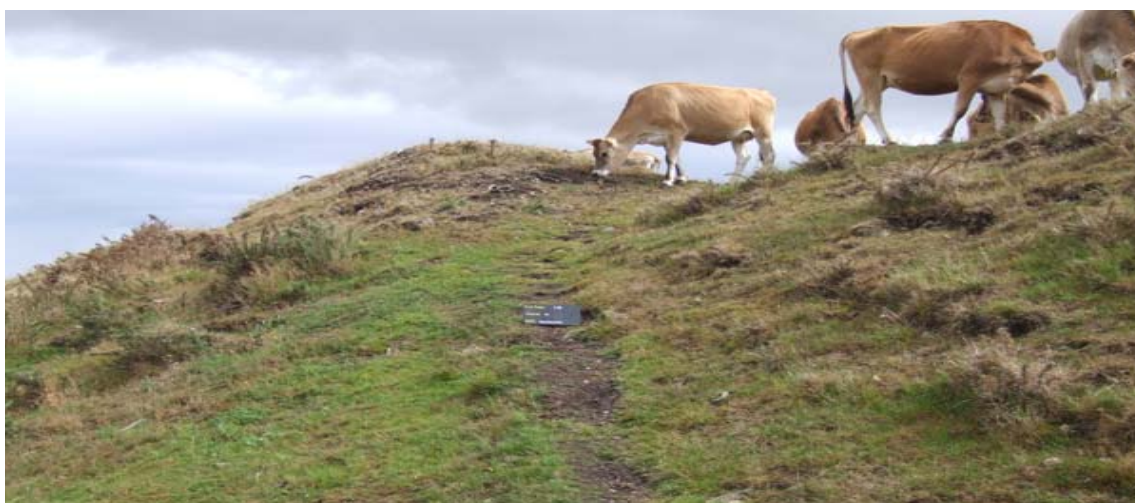
7.1.2 It is likely that the visible stock erosion has been in place for years, as many of the rampart breaches such as those associated with Tracks 10, 52 and 54, are significant and are likely to have taken some time to 'wear' through the rampart. Again, like the visitor tracks, these are now established and show continued use, causing further but localised damage.

PLATE 2: STOCK DAMAGE 10 OF RAMPART BANK AND SLOPE

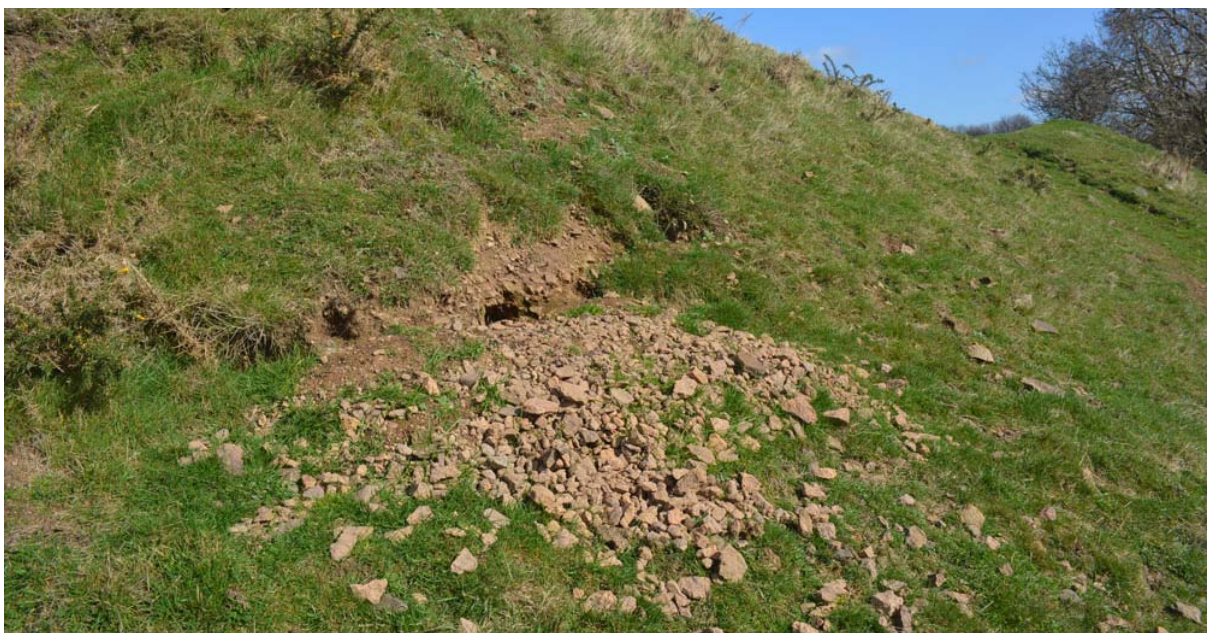
- 7.3.2 In very specific locations, for example, the south slope, where warrens and isolated burrows penetrate the once-covered gorse slopes (rabbit damage 43–48) the erosion represents a real threat to the structural integrity of the rampart, with deep burrows and clear activity throwing up large amounts of core material. As mentioned above (Section 6.1.3) rabbit damage (31-39) combine with cattle tracks (Tracks 52 and 53) to increase the level of collapse. It is unclear as to whether the rabbit population is increasing or has decreased at the present as new damage is clearly in evidence (Damage 58-62) but other locations seem to be no longer active. (Damage 32,33,35 &36).

PLATE 4: NEW RABBIT DAMAGE [48]

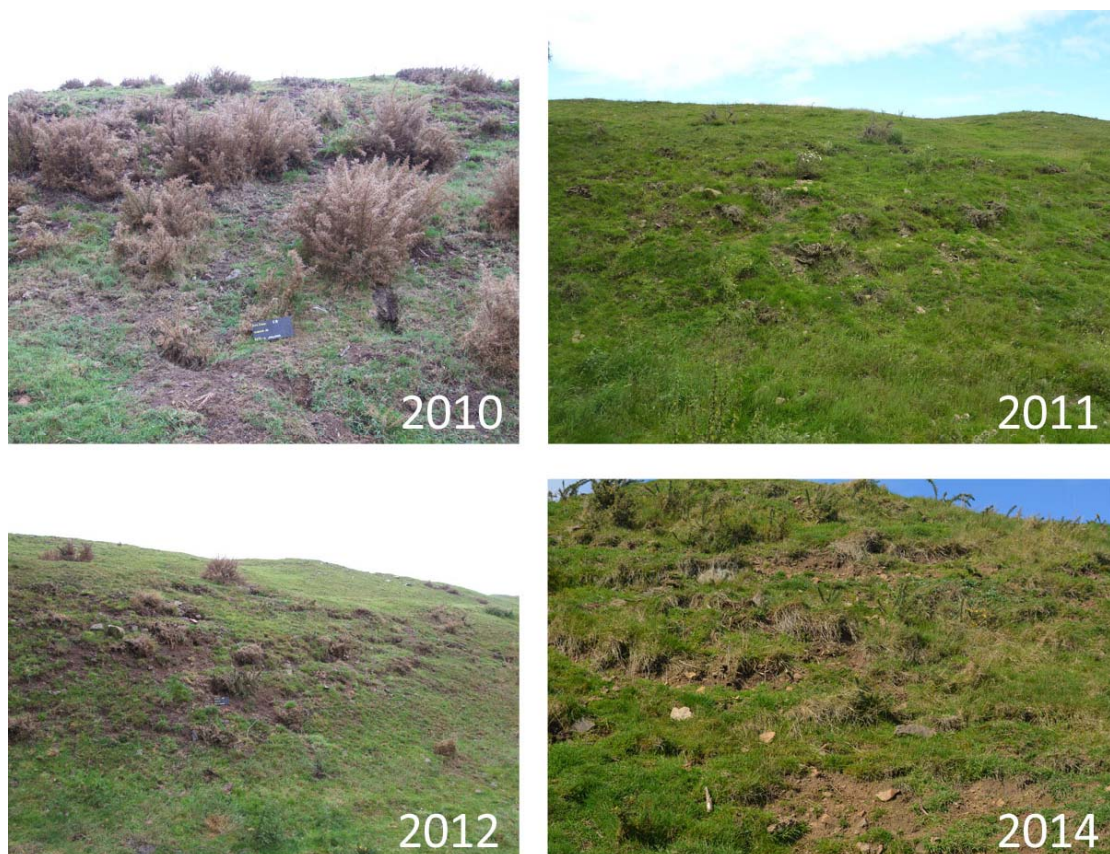
- 7.4.2 The nature of management is clear when studied over a number of years. As seen in plate 5, below, the initial cutting of gorse exposed the slope to erosion and although there was a period of repair to the rampart slope the recolonization by rabbits soon grew to levels where the area was compromised, and introduction of cattle to prevent gorse regrowth also resulted in trample and further deflation and slumping.

PLATE 5: DAMAGE 47 - COMPARATIVE DAMAGE RECORD EXAMPLE

- 7.4.3 Initial removal of gorse should be followed up by regular continuous assessment of the various issues in a quick walkround, that can provide an overview of potential new threats to the site. It is clear from this location that the gorse – though visually intrusive, has already damaged the surface as much as it can, while rabbit and animal tracks are far more destructive when allowed to continue unchecked.
