The Chesters, Drem, East Lothian

Erosion and Topographic Survey

Rampart Scotland Project 002:

Season 2

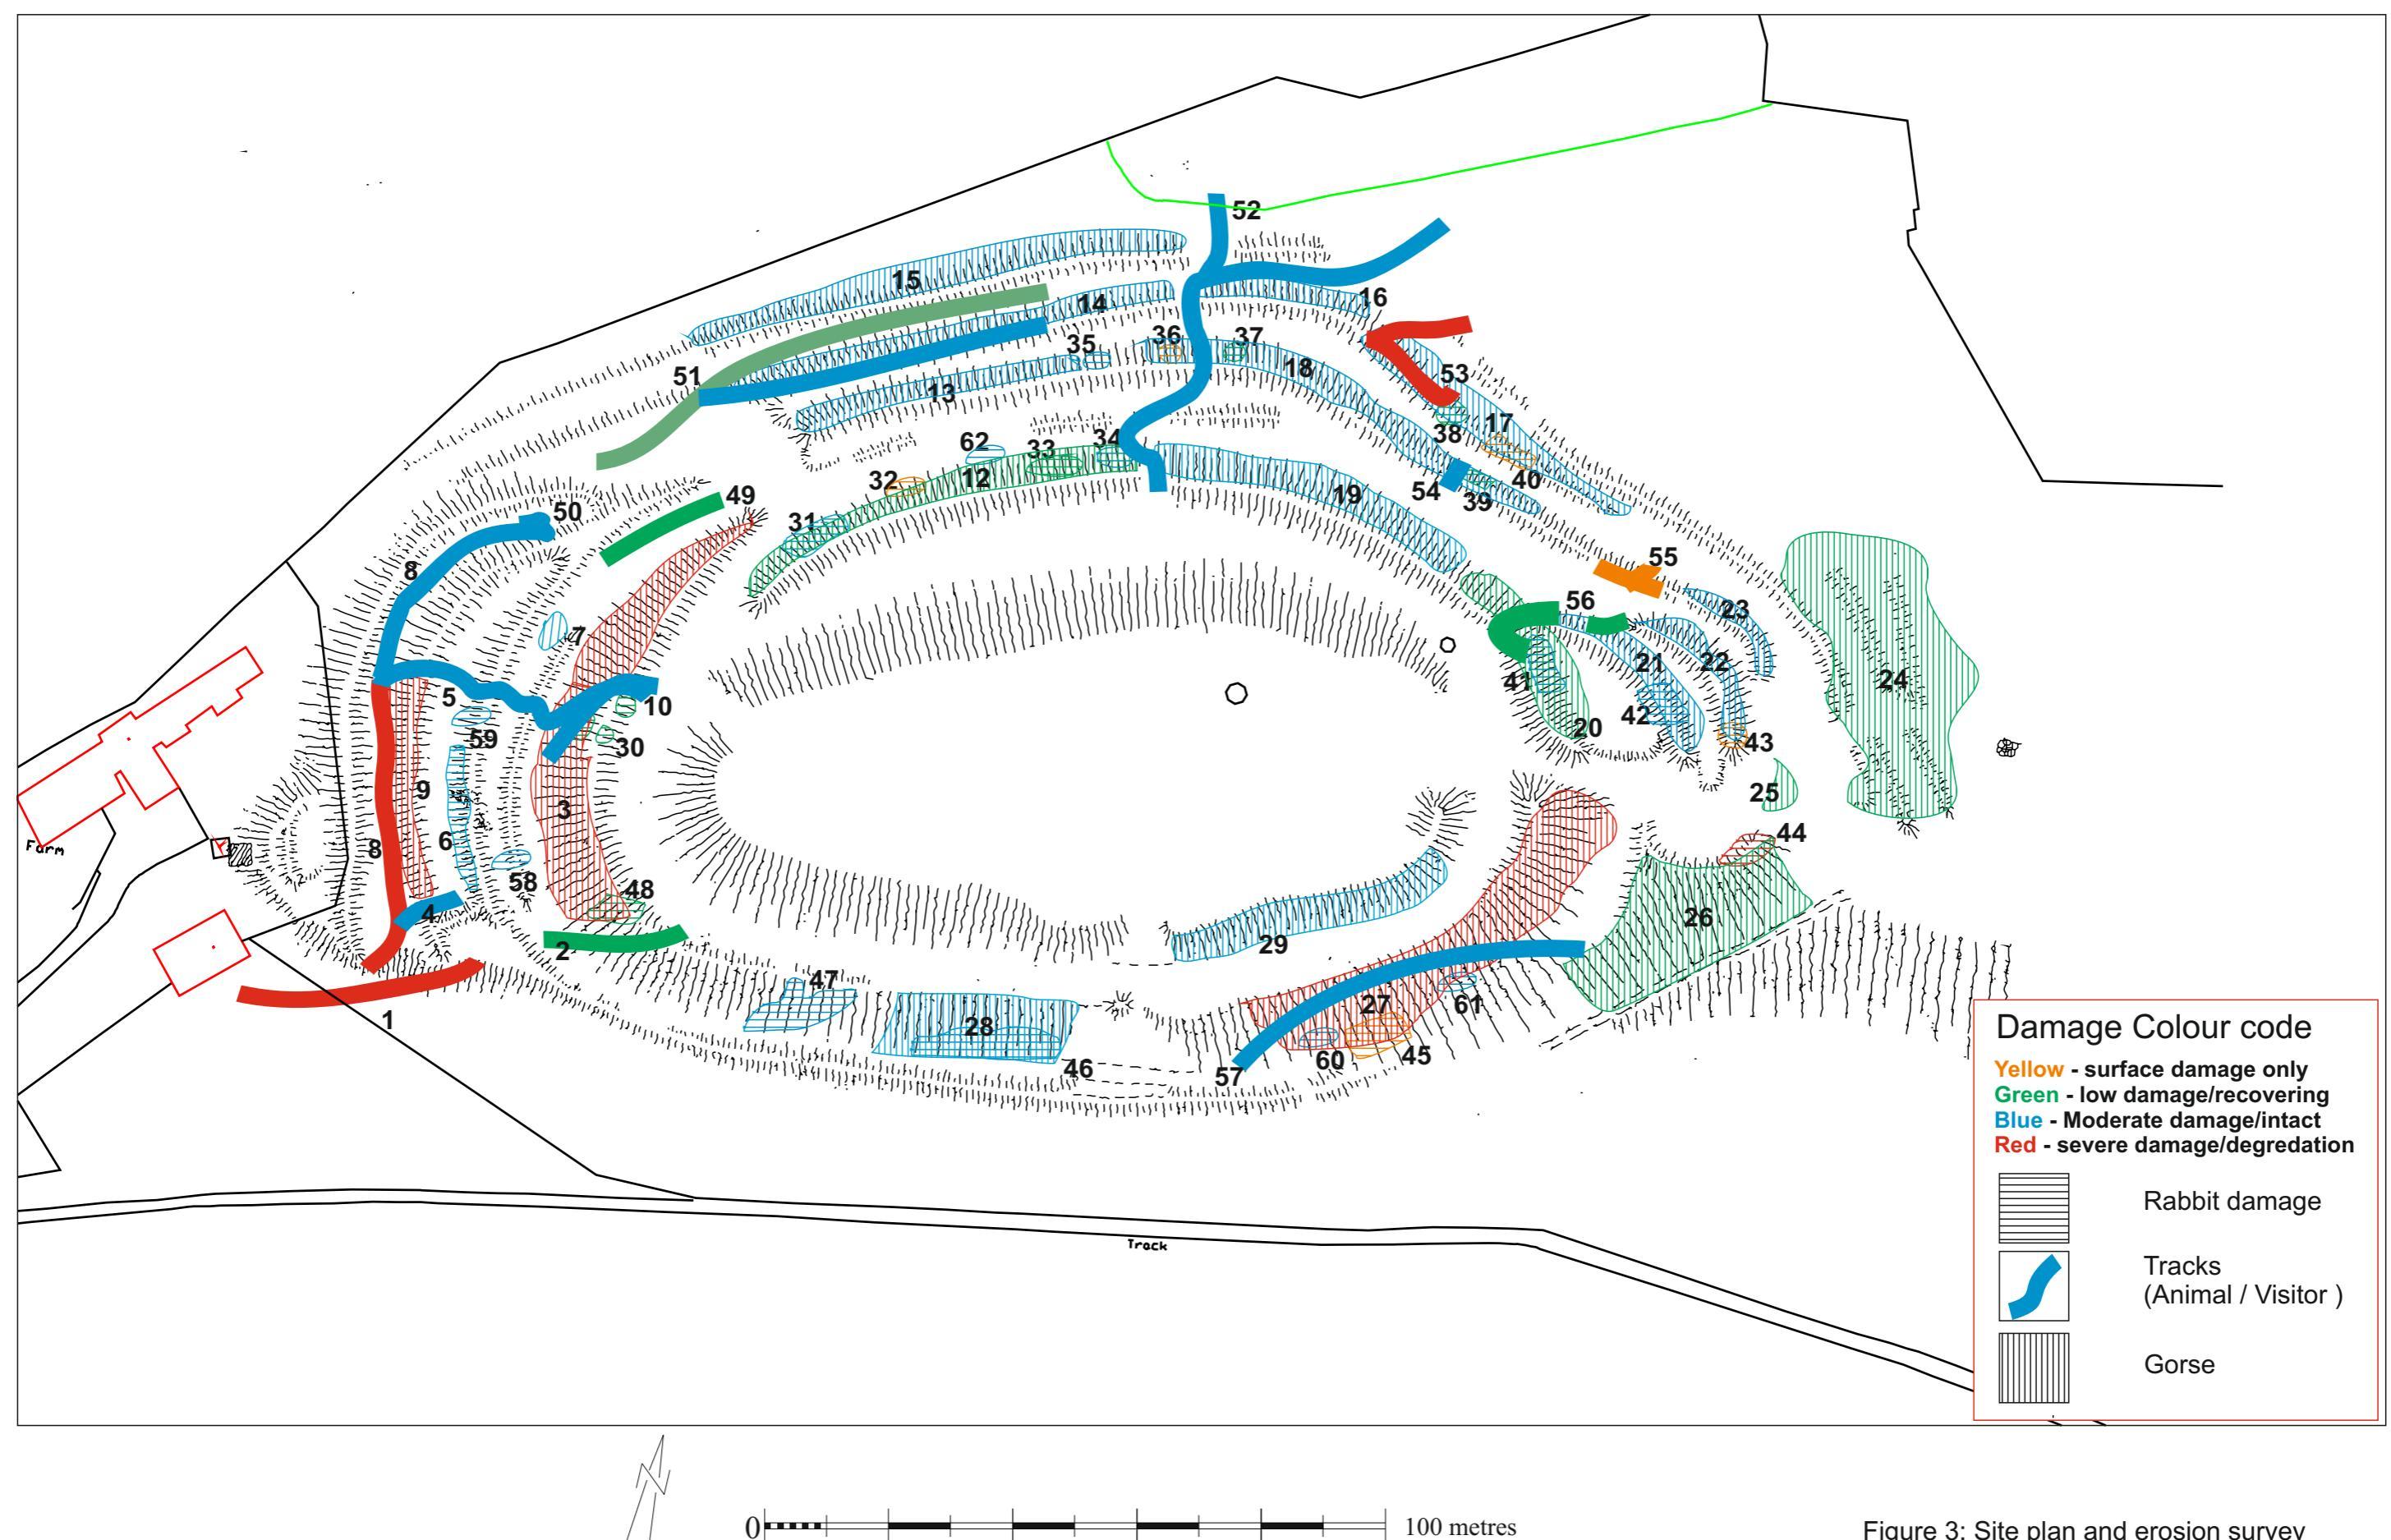
Figure 3: Site plan and erosion survey

The updated 2011 results of the survey are presented in Table 1 and Figure 3, with the associated photographic record presented in appendix.

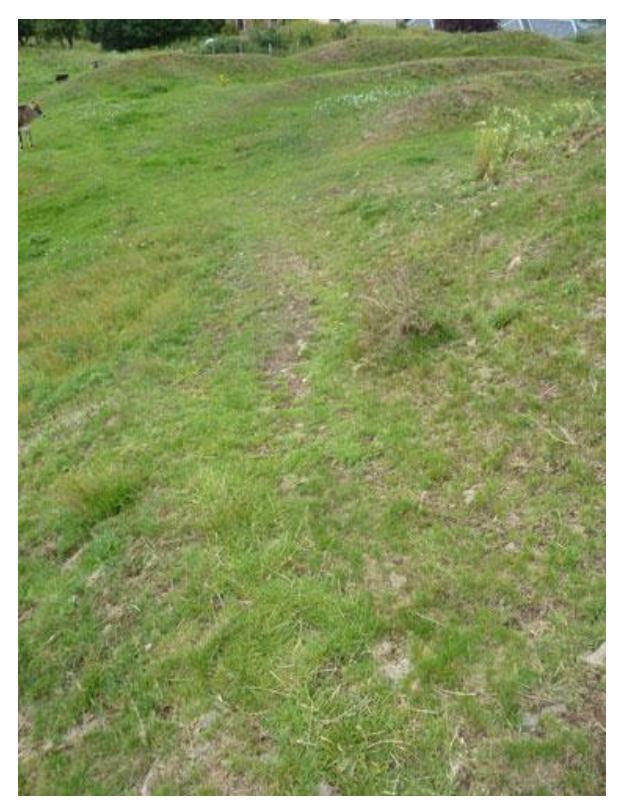
- 7.1.1 The damage from visitors is very localised and clearly follows established paths. Visitor access is focussed along Tracks 1 and 2, leading directly into the interior, and there is no evidence for *ad hoc* alternative routes. Of course while this activity minimises the overall spread of erosion it concentrates it in particular locations.
- 7.1.2 It is likely that the visible stock erosion has been in place for years, as many of the rampart breaches such as those associated with Tracks 10, 52 and 54, are significant and are likely to have taken some time to 'wear' through the rampart. Again, like the visitor tracks, these are now established and are in continued use, causing further damage.

PLATE 1: VISITOR DAMAGE 2 THROUGH UPPER RAMPART

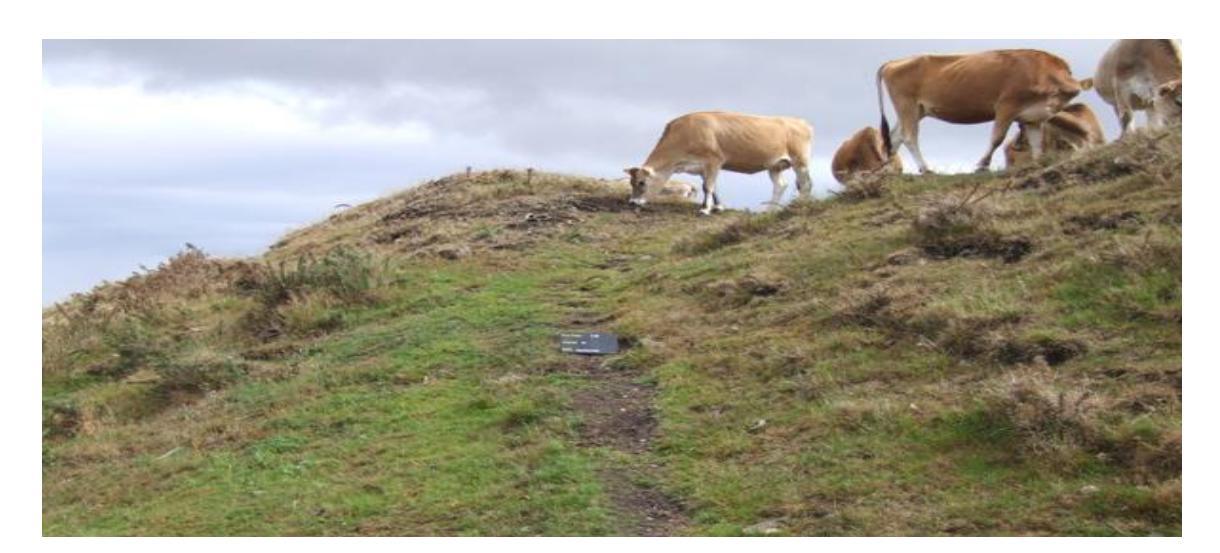
PLATE 2: STOCK DAMAGE 10 OF RAMPART BANK AND SLOPE

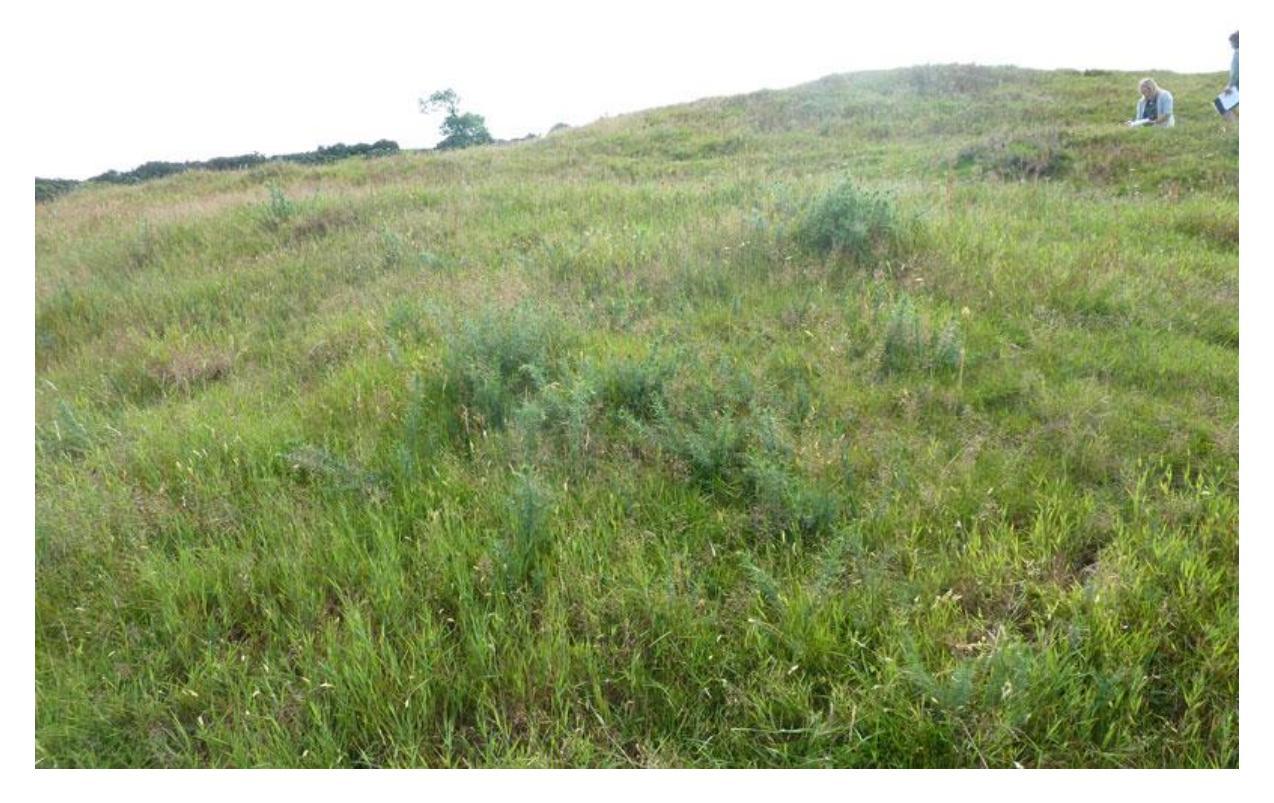
- 7.2.1 The 2010 gorse clearance removed large areas of this intrusive vegetation and is to be welcomed in principle. However, the removal resulted in the exposure of unvegetated and loose soil and rampart material leading to some erosion.
- 7.2.2 There is also clear evidence of gorse regeneration and it is recommended that the situation is continued to be monitored.
- 7.2.3 Several locations are showing signs of new growth, though this may be controlled with grazing, however, although some areas of gorse are showing no sign of life, there is a potential that gorse could begin re-colonisation if left unchecked.

PLATE 3: REGENERATING GORSE AREA 24.

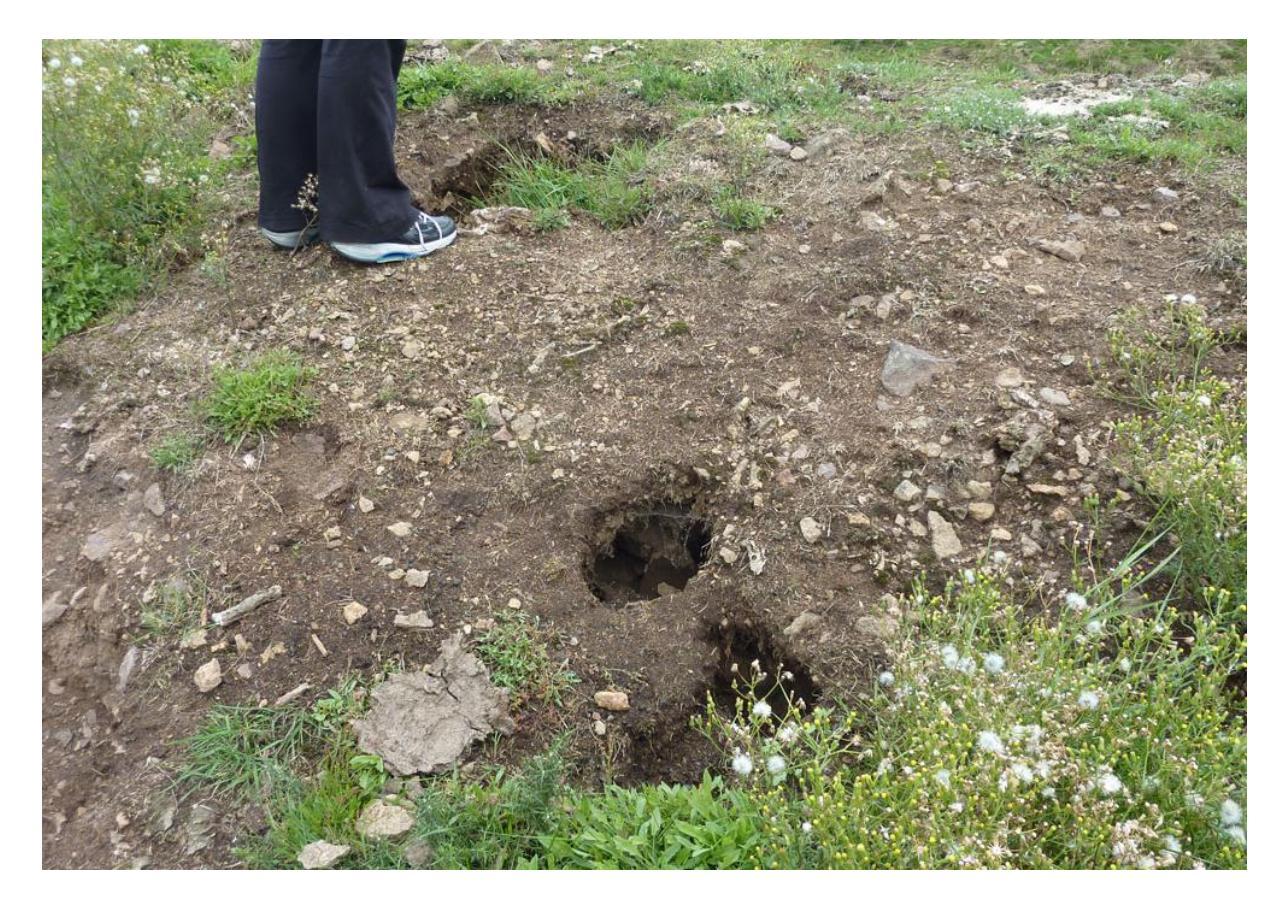
57	Stock Track		NEW	Active / Superficial Stock track trough cleared gorse area is causing visible damage.	
58	Rabbit burrow		NEW	Active / Intrusive Active burrows with large amount of fresh soil from bank core	
59	Rabbit burrow		NEW	Active / Intrusive Active burrows (3) with fresh soil from bank core

PLATE 4: NEW RABBIT DAMAGE [59]

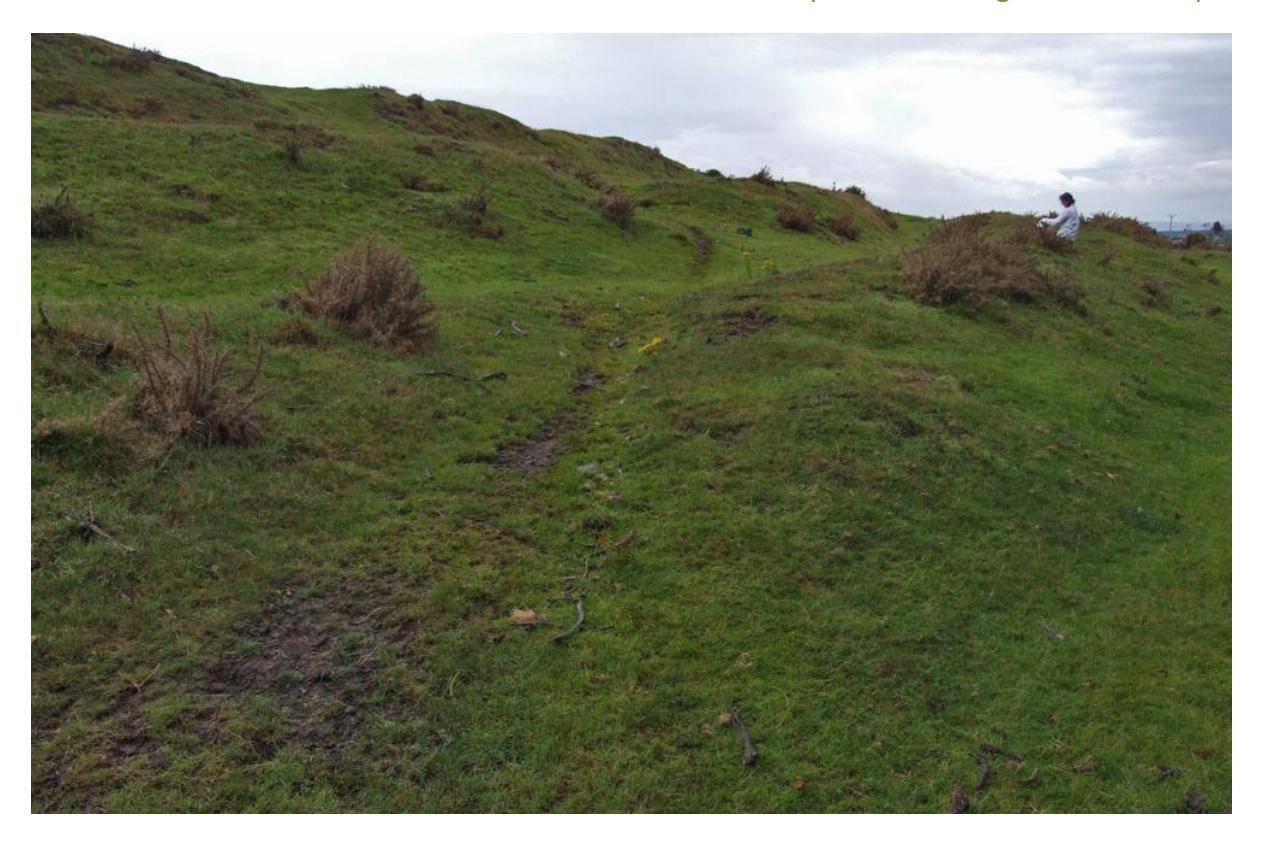
PLATE 5: DAMAGE 56 IN 2010

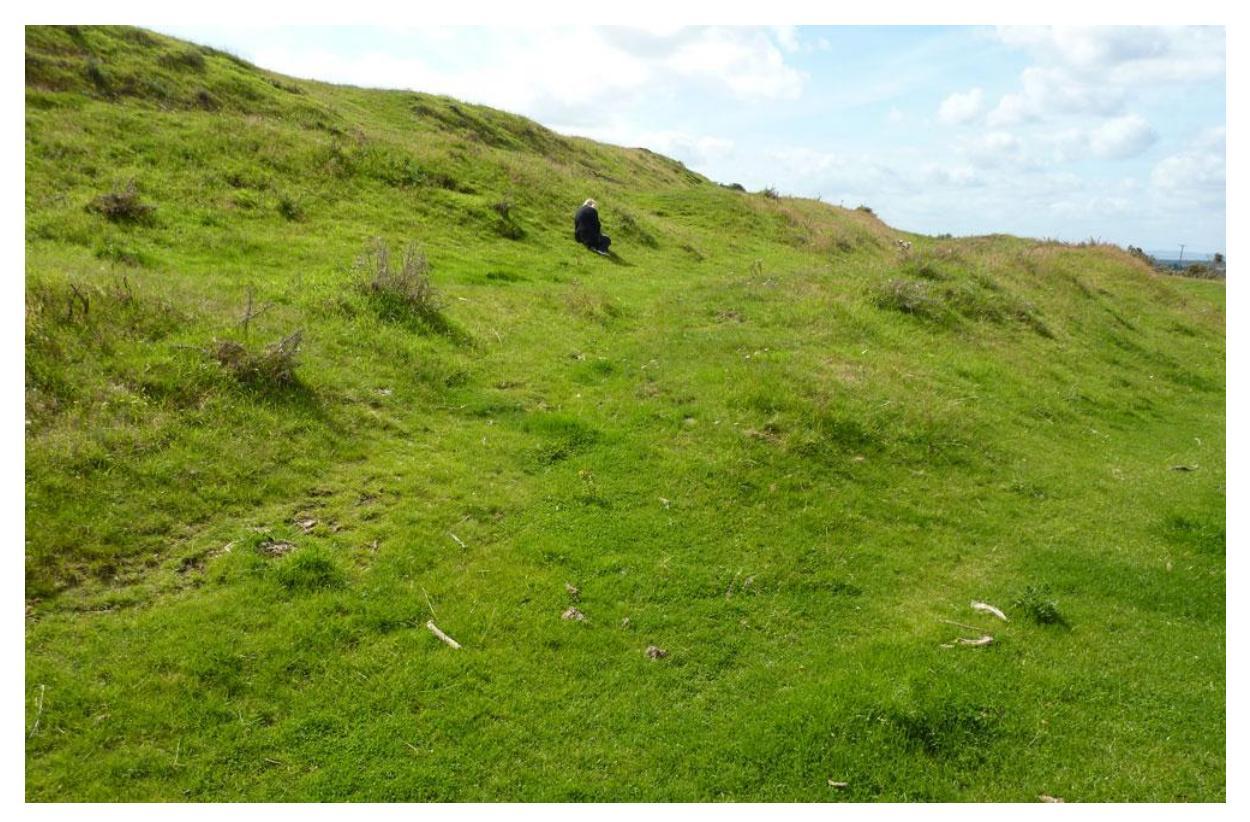
PLATE 6: DAMAGE 56 IN 2011

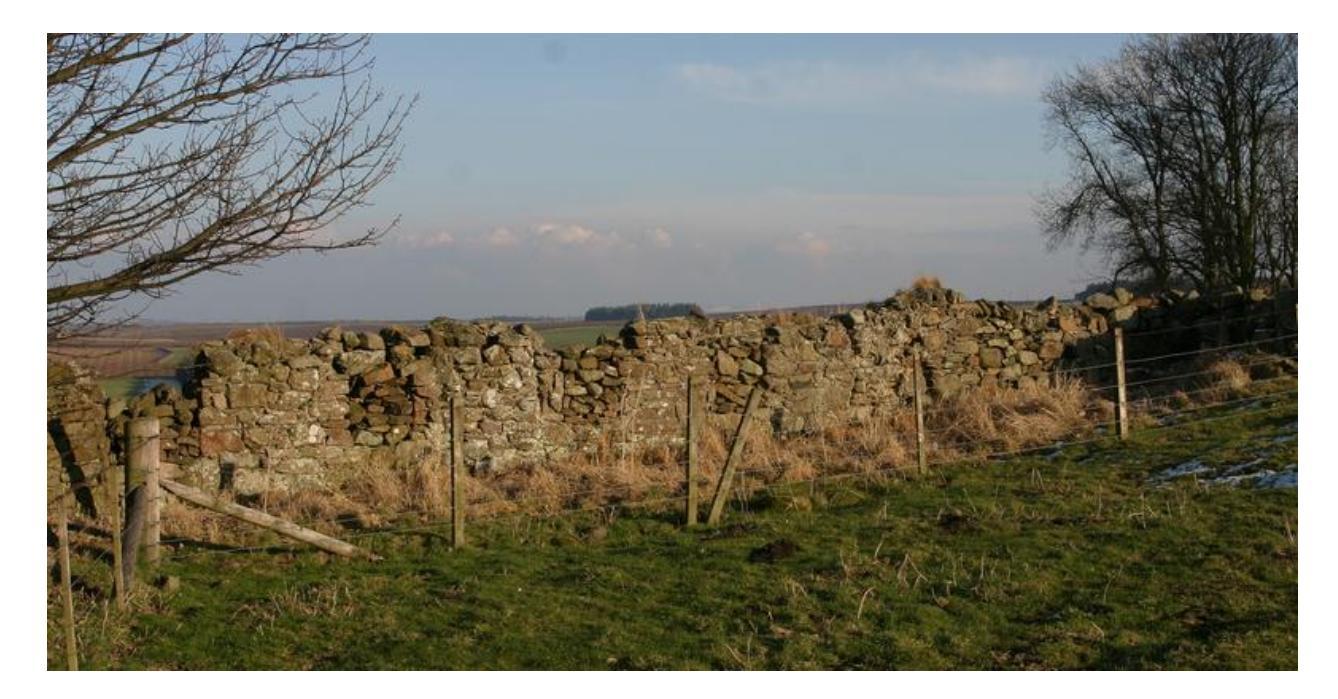
PLATE 10: BLOCKED WINDOWS AND DOORS OF 'OLD' DREMHILLS FARM, IN THE NORTHEAST WALL.
