The Chesters, Drem, East Lothian

Erosion and Topographic Survey

Rampart Scotland Project 002:

Season 2

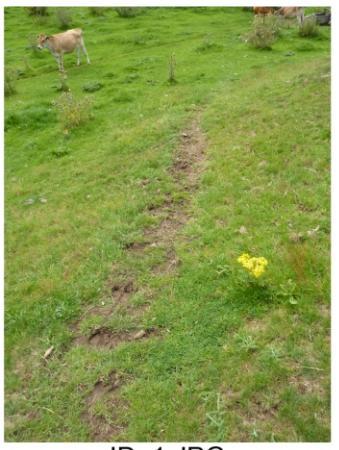
ID_1.JPG

Туре	State / Scale 2010	2011 Condition	Notes	
1	Visitor track	Active / Superficial From visitor entrance onto site	No Change	From layby to interior, crossing all ramparts	
2	Visitor track	Active / Intrusive Over ramparts and ditch, deep cutting and up to 1.60m wide	Improvement	Seems to show signs of regeneration of grass cover	
3	Cut Gorse	Stabilised / Intrusive	No Change	Although not regenerated, there are signs of new growth.	
4	Visitor track	Active / Intrusive Track over rampart causing slumping	Improvement	Seems to show signs of regeneration of grass cover	
5	Cattle track	Active / Superficial Beside fence	No Change		
6	Rabbit scrapes	Active / Intrusive Exposes bedrock and rampart material	Improvement	Signs of stabilisation and grass cover	
7	Cut Gorse	Stabilised / Intrusive	Improvement	No sign of regrowth and bank material stabilised	
8	Visitor/Anim al track	Active / Intrusive Over ramparts and ditch, deep cutting and up to 60cm wide	No Change

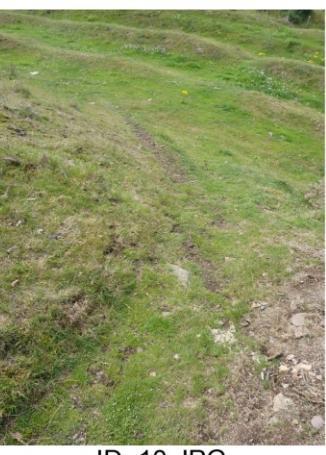
ID_10.JPG

Туре	Condition / Scale 2010	Condition 2011	Notes
9	Cut Gorse	Stabilised / Intrusive Although stabilising, there has been erosion of material down slope	Worse	New growth and heavy erosion of bank
10	Visitor track	Active / Intrusive Track causing serious damage to rampart, creating a deep cut	No Change	
11	Cut Gorse	Stabilised / Superficial Roots have exposed soil for erosion	No Change	Signs of new growth appearing
12	Cut Gorse	Stabilised / Superficial Roots have exposed soil for erosion	No Change	Signs of new growth appearing though previous bank material slumping has stabilised
13	Cut Gorse	Active / Intrusive Roots have exposed soil for erosion	No Change	Signs of new growth appearing
14	Cut Gorse	Active / Intrusive Gorse is regenerating – roots causing further damage to rampart	No Change	Signs of new growth appearing though previous bank material slumping has stabilised
15	Cut Gorse	Active / Intrusive Gorse exposed rampart	No Change	Signs of new growth appearing

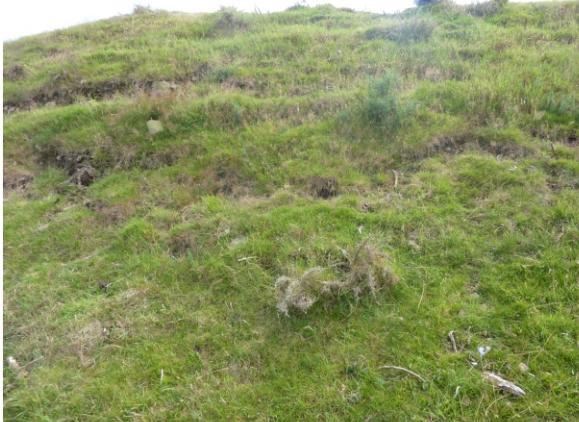
ID_19.JPG

Туре	Condition / Scale 2010	Condition 2011	Notes
19	Cut Gorse	Active / Intrusive Gorse is regenerating – roots causing further damage to rampart	No Change	
20	Cut Gorse	Active / Intrusive Roots have exposed soil for erosion	Improvement	No sign of regrowth and bank material stabilised
21	Cut Gorse	Active / Intrusive Roots have exposed soil for erosion - regenerating	No Change	Signs of new growth appearing though previous bank material slumping has stabilised
22	Cut Gorse	Active / Intrusive Roots have exposed soil for erosion - regenerating	No Change	Signs of new growth appearing though previous bank material slumping has stabilised
23	Cut Gorse	Active / Intrusive Roots have exposed soil for erosion -	No Change	Signs of new growth appearing though previous bank material slumping has stabilised
24	Cut Gorse	Active / Superficial Roots have exposed soil for erosion - regenerating	No Change	Signs of new growth appearing though previous bank material slumping has stabilised

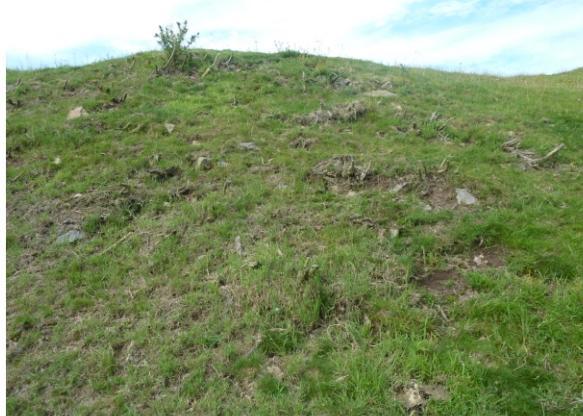
ID_28.JPG

Туре	Condition / Scale 2010	Condition 2011	Notes
28	Cut Gorse	Active / IntrusiveRoots have exposed soil for erosion	Improvement	No sign of regrowth and bank material stabilised
29	Cut Gorse	Active / Intrusive Roots have exposed soil for erosion – rampart & core exposed	Improvement	No sign of regrowth and bank material stabilised though stone core and revetment of rampart is now exposed
30	Isolated Burrow	Old / Intrusive Exposes stone core of rampart	No Change	Still active
31	Isolated Warren	Active / Intrusive 5 burrows evident	No Change	Still active
32	Isolated Warren	Active / Intrusive 8 burrows evident	Improvement	Rabbits no longer active
33	Isolated Warren	Stabilised / Intrusive 3 burrows evident	Improvement	Rabbits no longer active
34	Area Warren	Active / Intrusive 12-15 burrows evident – extensive undermining of rampart	Worse	Still active – causing more damage to banks
35	Area Warren	Active / Intrusive 10 burrows evident with deep scarring of rampart exterior face	Improvement	Rabbits no longer active
